CAPSULE SUMMARY SHEET

Survey No.: M: 28-51 Construction Date: circa 1885, 1941-1947
Name: Round Oak Missionary Baptist Church
Location: 15812 Good Hope Road, Silver Spring vicinity (Cloverly), Montgomery County

Maryland Historical Trust
Maryland Inventory of Historic Properties Form
Intercounty Connector Project

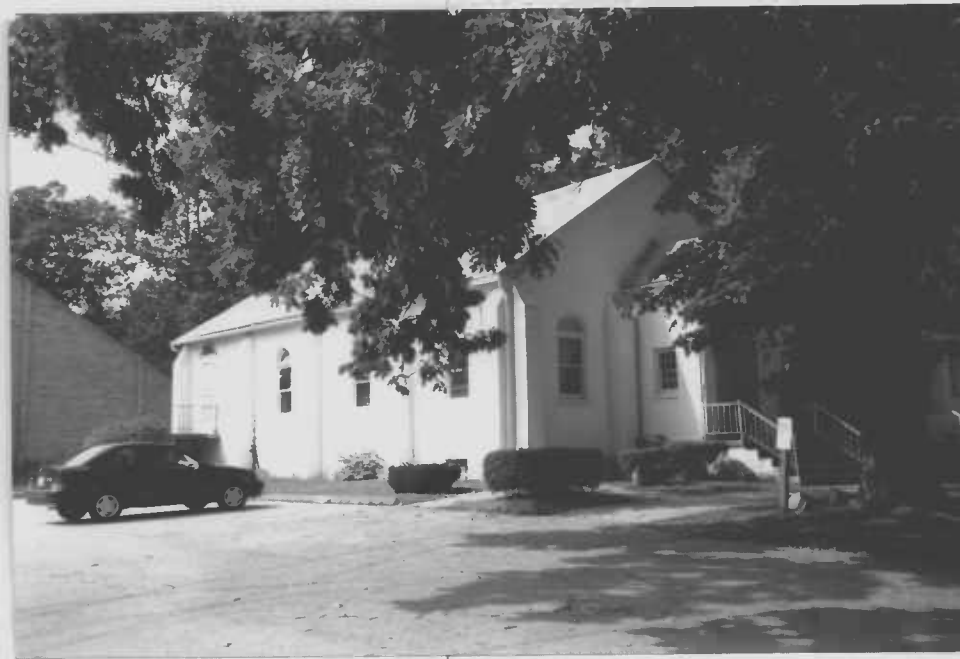
The east, or front elevation has a projecting gable entry with a wood double door with raised panels, accessed from grade by concrete steps. The first bay has a round arch, leaded stained glass window between two buttresses. Most of the third bay has been concealed by the north addition.

The south elevation has five buttresses that extend to the roof overhang. Between the buttresses are three round arch, leaded stained glass windows and one wood door. The door, which has decorative raised panels and concrete steps to grade, has a round arch leaded stained glass transom.

1. M: 28-51
2. Round Oak Missionary Baptist Church
3. Montgomery Co., MD
4. PAC Spero & Co.
5. 8/97
6. MD SHPO
7. Church, south & east elevations
8. 1 of 15

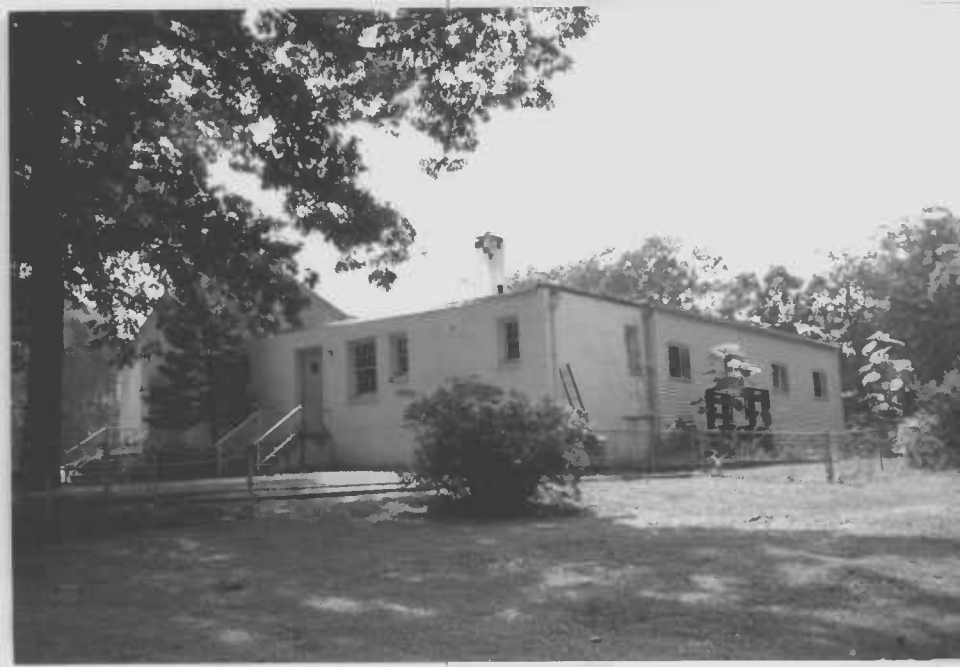
The north elevation is concealed by the 1-story, flat-roof addition. The addition was built in two sections. The east section, constructed in 1953, is a stucco covered concrete block entry hall with a wood door and five 4/4 double-hung wood windows. The west section, constructed in 1973 and enlarged in 1977, has vinyl siding, a wood door, and seven vinyl sliding windows.

1. M: 28-51
2. Round Oak Missionary Baptist Church
3. Montgomery Co, MD
4. PAC Spero & Co.
5. 8/97
6. MD SHPO
7. Church, north & east elevations
8. 2 of 15

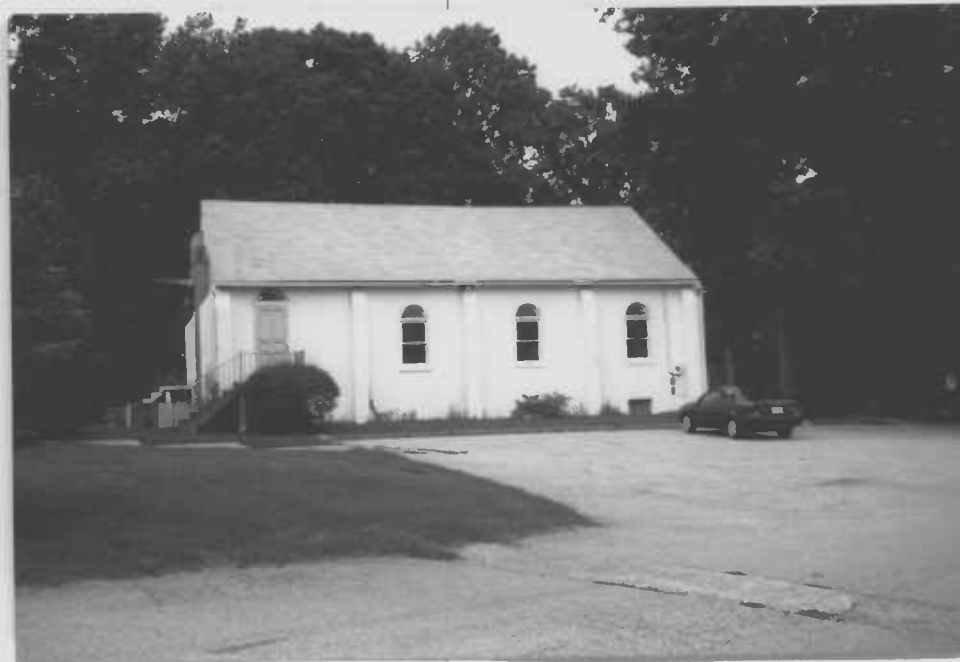
1. M: 28-51
2. Round Oak Missionary Baptist Church
3. Montgomery Co., MD
4. PAC Spaw & Co.
5. 8/97
6. MD SHPO
7. Church, south elevation
8. 3 of 15

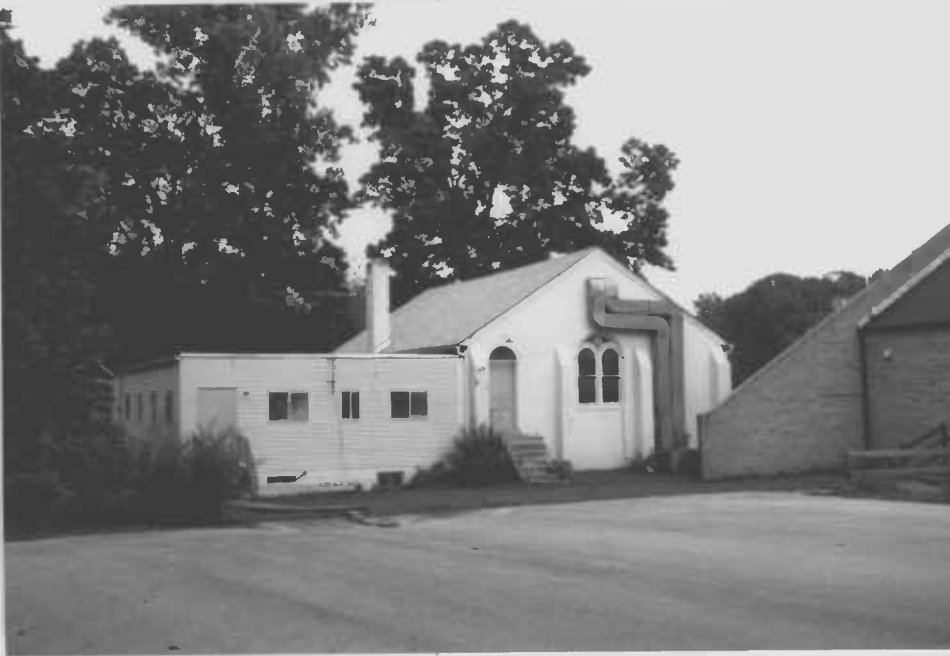
The west, or rear elevation has four buttresses and a paired, round arch, leaded stained glass double-hung wood window. The window is located in the center of the elevation. The first bay has a wood door with a round arch leaded stained glass transom. The door is accessed by concrete steps. The third bay has air handling unit ductwork secured to the exterior wall.

1. M: 28-51
2. Round Oak Missionary Baptist Church
3. Montgomery Co., MD
4. PAC Spero & Co.
5. 8/97
6. MD SHPO
7. Church, west elevation
8. 4 of 15

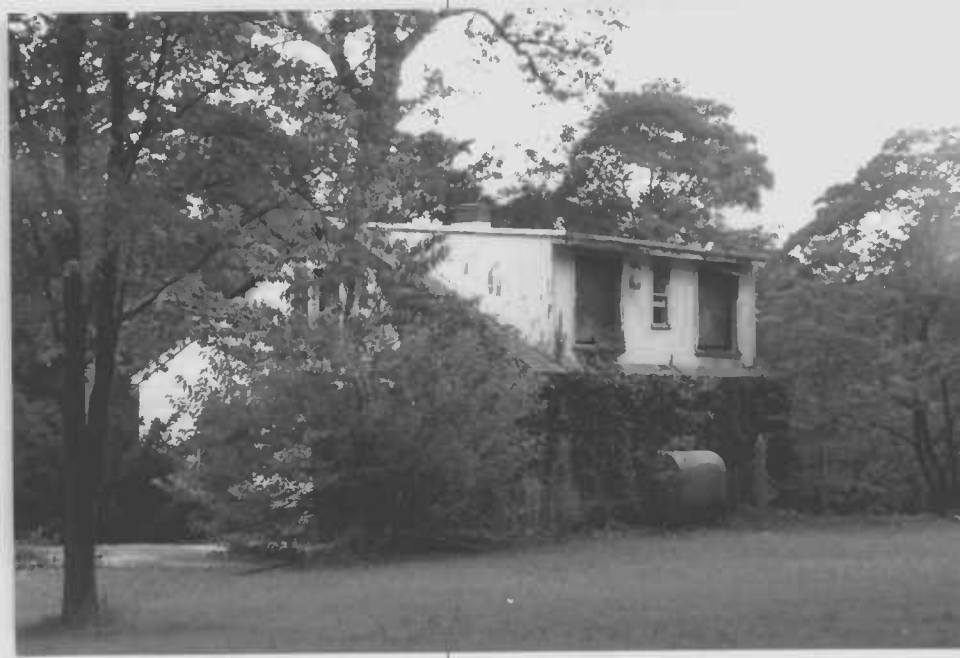
The first building associated with this property is a residence. Constructed circa 1945, the residence is a small, 1½-story, side-gable concrete block cottage. The structure is in deteriorated condition and many of the windows have been removed. It has an asphalt shingle roof with a large, plywood sheathed shed-roof dormer on the east side.

1. M: 28-51
2. Round Oak Missionary Baptist Church
3. Montgomery Co., MD
4. PAC Spero & Co.
5. 8/97
6. MD SHPO
7. residence, south & east elevations
8. 5 of 15

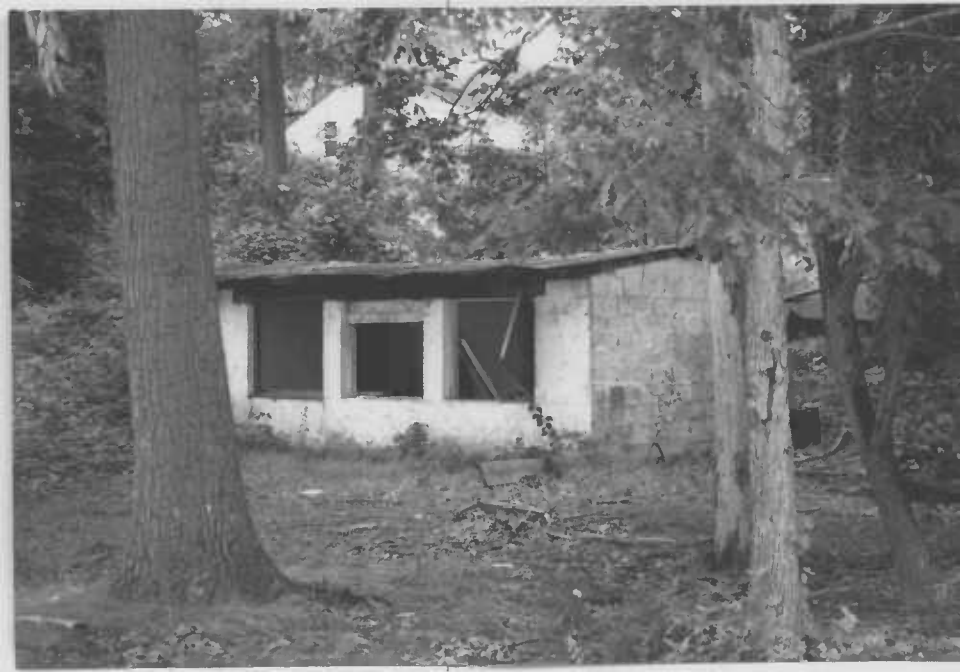
The second building is a small 1-story, concrete block shed with an standing seam metal, side-gable roof. The shed, constructed circa 1945, is in deteriorated condition; the door has been removed and there are three large openings on the west elevation. The shed is located west of the church and northeast of the residence. The first and second buildings were acquired by the church in 1987.

1. M: 28-51
2. Round Oak Missionary Baptist Church
3. Montgomery Co, MD
4. PAC Sprio & Co.
5. 8/97
6. MD SHPO
7. shed, south & east elevations
8. 6 of 15

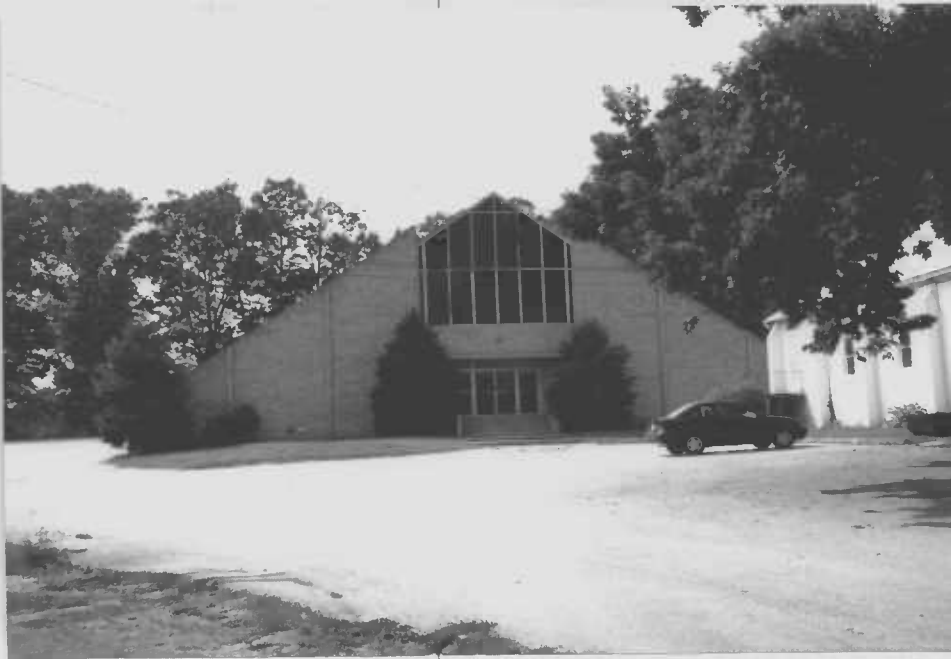
The third building is a large 1½-story church sanctuary and offices, constructed in 1982. The church is of concrete block construction with brick veneer. The east, or front elevation has a front-gable brick veneer facade with glass doors and a section of enamel panels in the gable end. The church is located a short distance west of the historic church.

1. M: 28-51
2. Round Oak Missionary Baptist Church
3. Montgomery Co., MD
4. PAC Spens & Co.
5. 8/97
6. MD SHPO
7. modern church, east elevation
8. 7 of 15

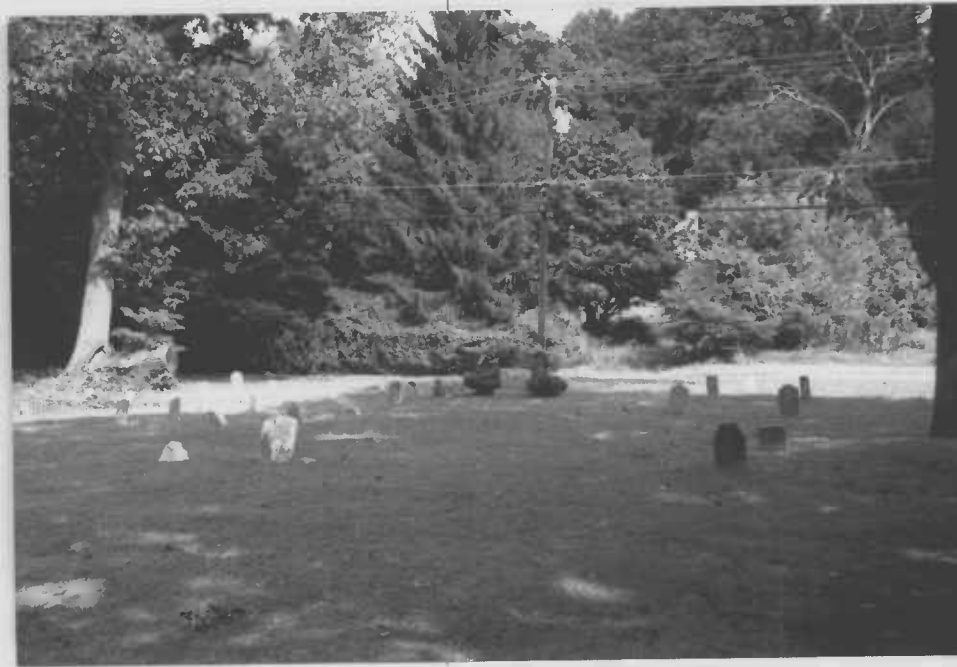
There are a cemetery and three buildings associated with this property. The cemetery, which is located northeast of the church, is laid out in a grid pattern with the stones facing east. The earliest stone located dates from 1888. Many of the stones, especially the stones from circa 1920 to circa 1945, have simple, hand carved inscriptions. The remaining stones are standard engraved types. Several of the stones have been broken and the inscriptions have been worn or damaged. Evidence indicates that the cemetery was still in use in the 1950s.

1. M: 28-51
2. Round Oak Missionary Baptist Church
3. Montgomery Co., MD
4. PAC Spero & Co.
5. 8/97
6. MD SHPO
7. cemetery
8. 10 of 15

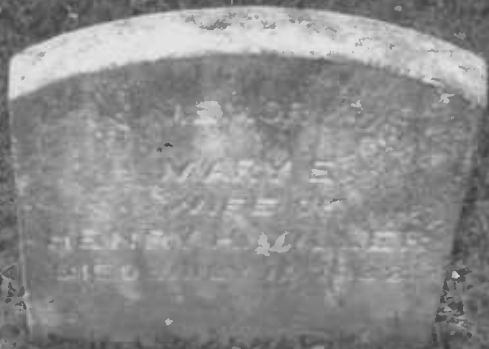
1. M: 28-51
2. Round Oak Missionary Baptist Church
3. Montgomery Co., MD
4. PAC Spero & Co.
5. 8/97
6. MD SHPO
7. 1888 headstone
8. 11 of 15

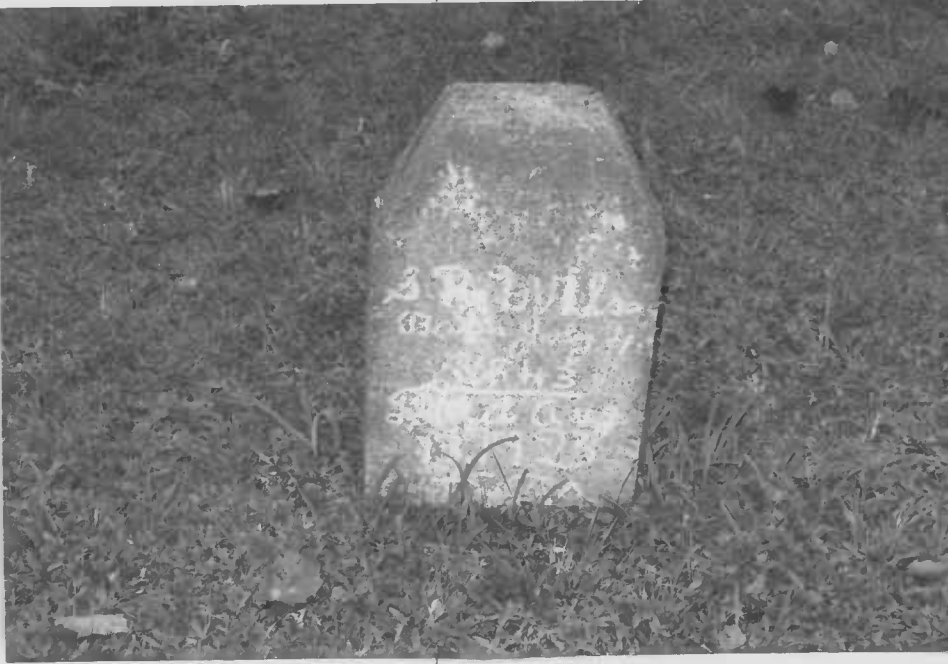
1. M: 28-51
2. Round Oak Missionary Baptist Church
3. Montgomery Co., MD
4. PAC Spaw & Co.
5. 8/97
6. MD SHPO
7. 1923 headstone
8. 12 of 15

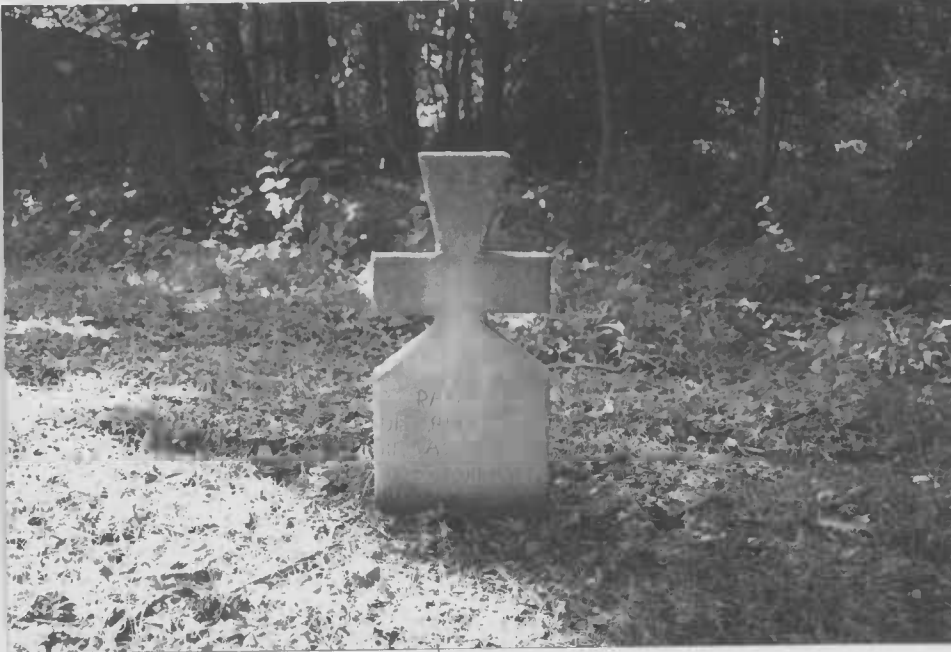
1. M: 28-51
2. Round Oak Missionary Baptist Church
3. Montgomery Co., MD
4. PAC Sporo & Co.
5. 8/97
6. MD SHPO
7. 1945 headstone
8. 13 of 15

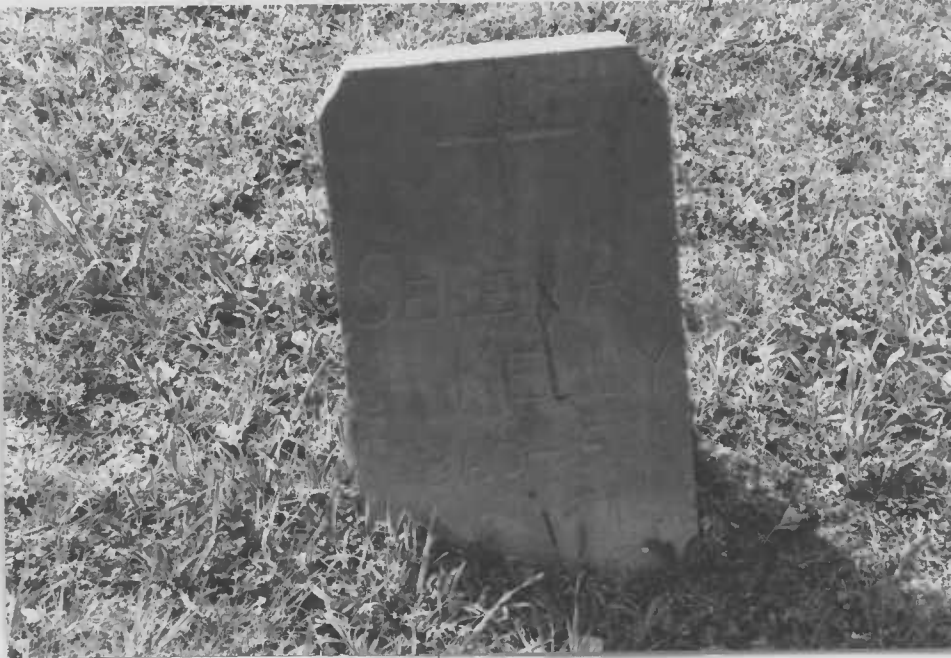
1. M: 28-51
2. Round Oak Missionary Baptist Church
3. Montgomery Co, MD
4. PAC Spero & Co.
5. 8/97
6. MD SHPO
7. 1930 headstone
8. 15 of 15
